Ionising radiation effects in a soft X-ray CMOS image sensor

Charles Townsend-Rose^{*}, Thomas Buggey, James Ivory, Konstantin D. Stefanov, Andrew D. Holland

Centre for Electronic Imaging, The Open University, Walton Hall, Milton Keynes, MK7 6AA, UK

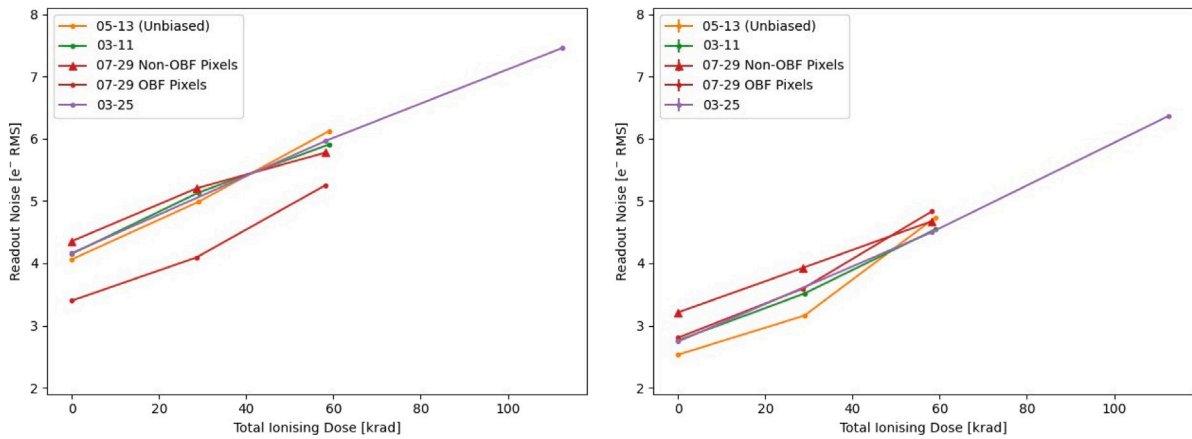
Fig. 1. CIS221-X readout noise measured at increasing total ionising dose inclusive (left) and exclusive (right) of a contribution from dark signal generated during readout. Data were collected with the image sensor cooled to $-40\text{ }^{\circ}\text{C}$.

Readout noise was measured using 50 dark frames. Dark current was not suppressed during data collection and therefore the initial measurement is a combination of both the noise from the on-chip readout electronics and the shot noise from the dark signal generated during readout. To decouple these two noise sources, the dark signal was subtracted using values derived from the dark current measurement (see Section 3.2). Fig. 1 shows the readout noise measured at increasing TID before (left) and after (right) dark signal subtraction. For all devices, the noise increased with TID at a similar rate; biasing and the presence of an OBF did not significantly influence the results. Prior to dark signal subtraction, the readout noise of the 07-29 non-OBF pixels is greater than that of the 07-29 OBF pixels. However, following dark signal subtraction, they report similar values. This suggests an offset in the dark current of the non-OBF and OBF pixels of this device. This phenomenon has been reported previously [4] and is subject to ongoing investigation.

The observed degradation of readout noise is again similar to measurements reported for a CIS115 CMOS image sensor [5]. In both cases, the increase in readout noise could be explained by the buildup of trapped charge and the generation of interface states in the MOSFET gate oxide and surrounding shallow trench isolation (STI) [6]. To verify this as the cause of degradation to the CIS221-X readout noise, further investigation would be necessary.

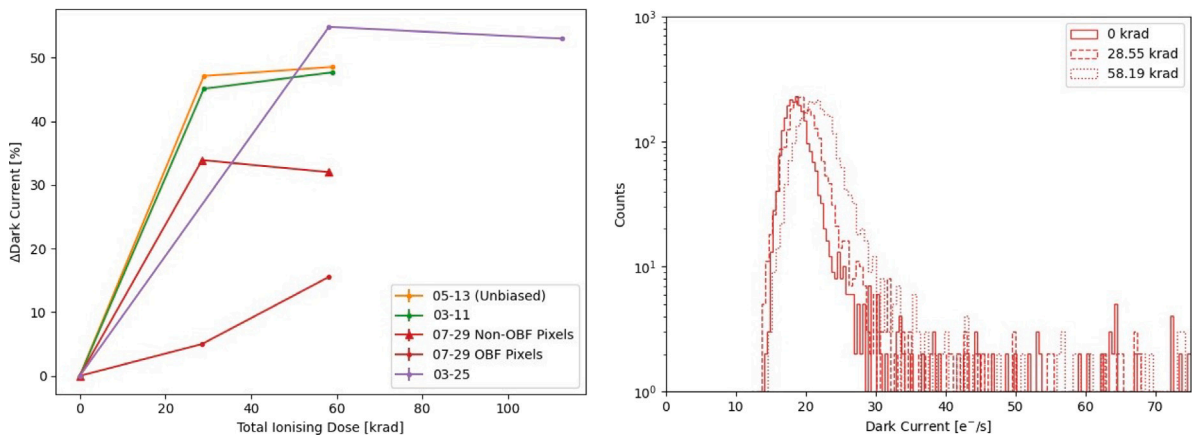
Fig. 2. CIS221-X dark current measured at increasing total ionising dose with the image sensor cooled to $-40\text{ }^{\circ}\text{C}$. Left: Percentage change in dark current for increasing total ionising dose. Right: Dark current distribution of 07-29 OBF pixels at increasing total ionising dose.

Following exposure to ionising radiation, the dark current increased in all CIS221-X devices. Though no significant difference was seen in the results of the unbiased device, Fig. 2 (left) shows the performance of the 07-29 OBF pixels degraded less than that of the 07-29 non-OBF pixels. Further, for all but the 07-29 OBF pixels, the rate of degradation decreased significantly for the final irradiation measurement. Fig. 2 (right) shows the 07-29 OBF pixel dark current distribution uniformly increasing with TID. This uniformity was seen in all devices.

The degradation of CIS221-X dark current is comparable to that reported for a similar fully depleted PPD CMOS image sensor [7] for which the result was attributed to radiation-induced interface traps at the exposed edges of the STI. To verify this explanation for the CIS221-X, further testing would be required. The decreased rate of degradation for the final irradiation measurement is likely due to annealing that

occurred during the ~ 45 days between the final irradiation and the final dark current measurement, while the sensors were stored at room temperature. This could be confirmed through further data collection.

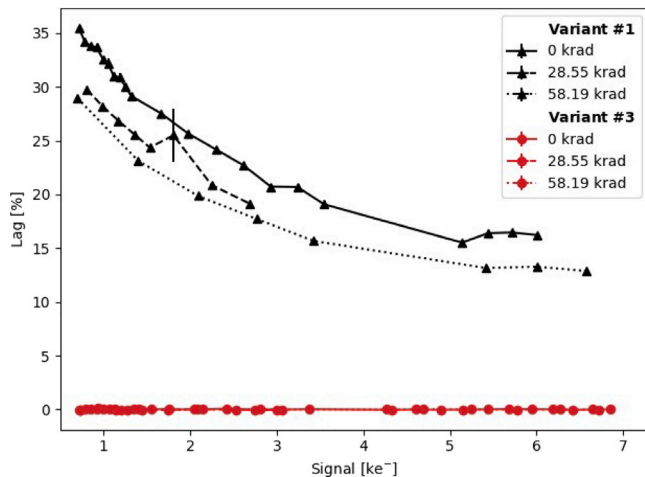
Fig. 3. Leading-edge image lag of the CIS221-X ‘Variant #1’ and ‘Variant #3’ 40 μm pixels expressed as a percentage of signal and measured at increasing total ionising dose. Results are from the 07-29 Non-OBF pixels and are representative of all devices tested.

The leading-edge image lag was measured using pulsed LED illumination. The lag performance of the ‘Variant #1’ and ‘Variant #3’ pixels (the subject of discussion so far) are shown in Fig. 3 as a percentage of signal. ‘Variant #2’ has been excluded for the sake of readability but reported similar results to the pixels of ‘Variant #1’: significant image lag before irradiation which then decreases with increasing TID. The ‘Variant #3’ pixels, which feature a larger transfer gate, have near-zero lag and show no measurable change following irradiation.

For pinned photodiode CMOS image sensor pixels, the main cause of image lag is the presence of a potential barrier or pocket between the photodiode and transfer gate. Following exposure to ionising radiation, positive charge trapped around these regions can lower or deepen any potential barrier or pocket [8]. The behaviour of the CIS221-X ‘Variant #1/#2’ pixels can then be explained by the presence of a significantly large potential barrier that has lowered following exposure to ionising radiation.
